ODD FELLOWS HOME LAKE DAM

CLAY COUNTY, MISSOURI

MISSOURI INVENTORY NO. 11022

PHASE I INSPECTION REPORT

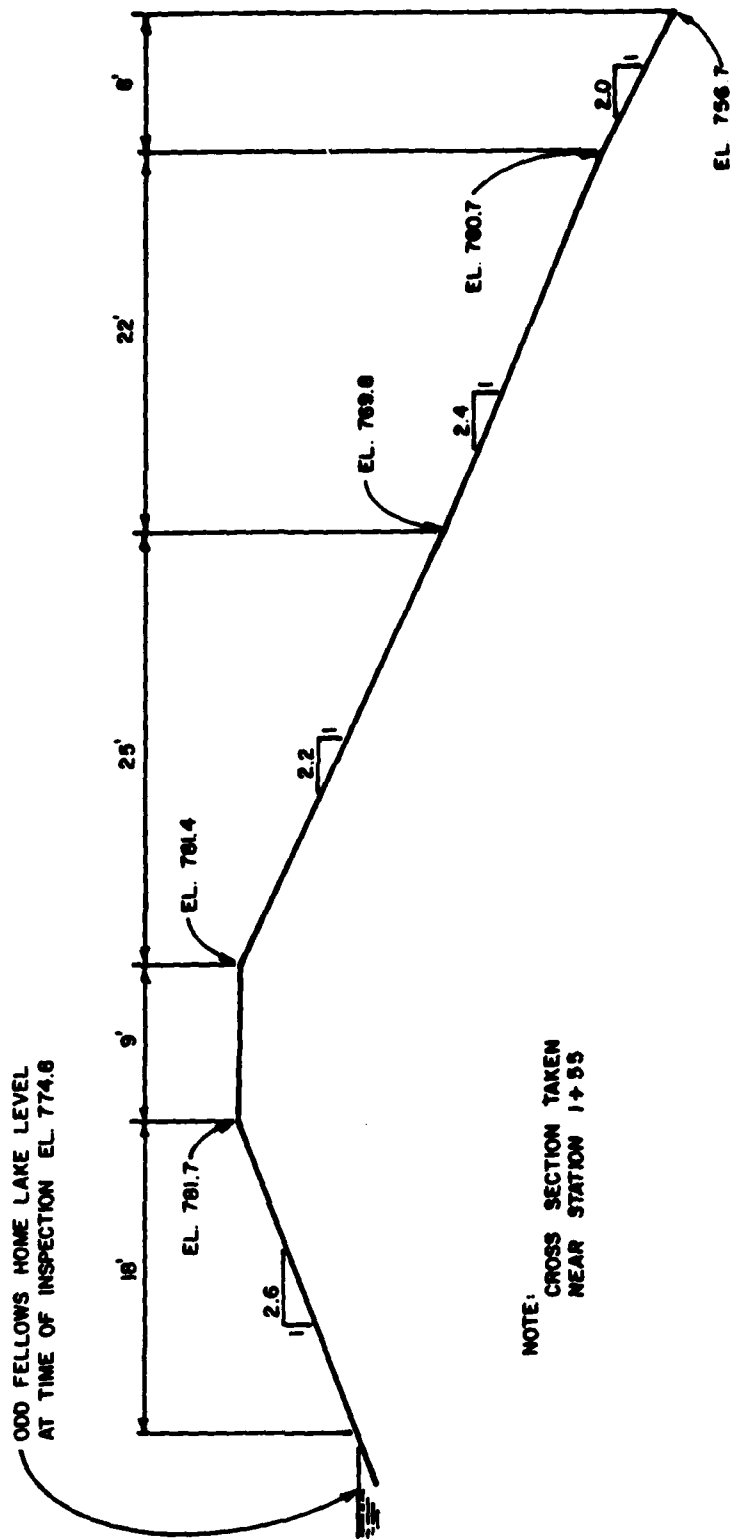
ODD FELLOWS HOME LAKE DAM DAM CROSS SECTION

ODD FELLOWS HOME LAKE LEVEL
AT TIME OF INSPECTION EL. 774.8
